Boundary Treatments

CASE STUDY - St Andrew's Townscape Heritage Initiative

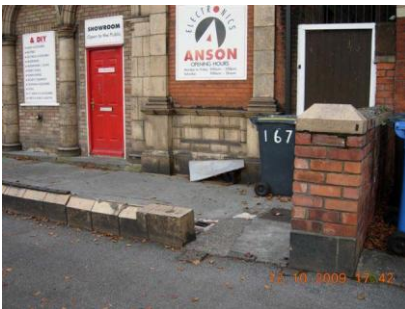
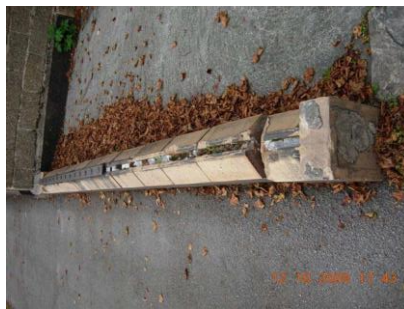
Before

Boundary treatment works were carried out during the St Andrew's Townscape Heritage Initiative at Anson Electronics. All of the railings were previously missing and some of the faience blocks were either missing or damaged. Existing on site physical evidence and archival documentation was consulted in order to establish the design and height of the original railings. The existing faience blocks were carefully numbered and removed from site for safe keeping. Templates from a specialist supplier were made to enable the missing and damaged faience blocks to be replaced.

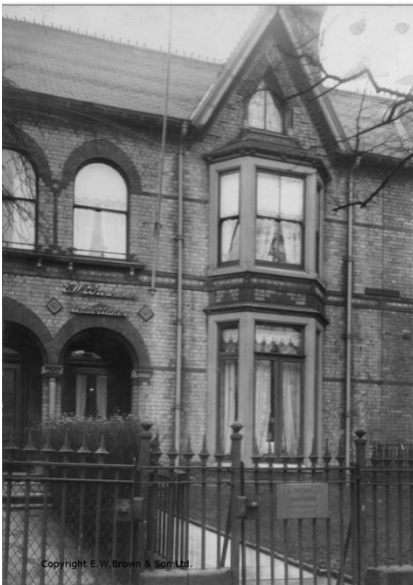
Early C20 photograph of 96 Beverley Road

The current boundary treatments at 94, 96 and 98 Beverley Road are inconsistent and detract from the rest of the terrace. The Scheme will reinstate stone plinths and railings boundary treatment consistent across whole terrace (to match the original in the photo above).

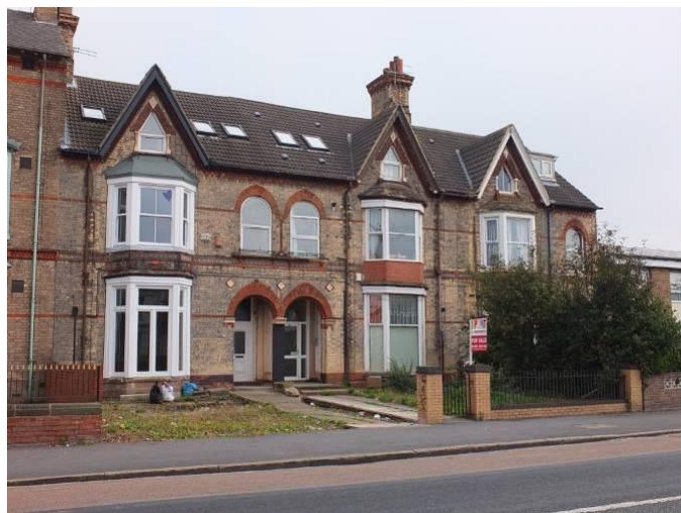
Recent photo of 96 Beverley Road

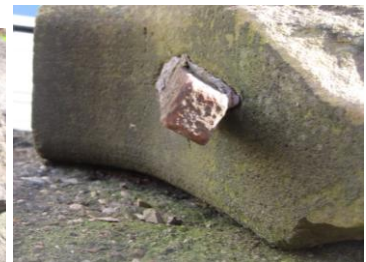
Surviving evidence of original plinths between 94-98 Beverley Road, including the size and shape of the original railings.
