Beverley Road Townscape Heritage Scheme

About the Properties

High Priority Projects

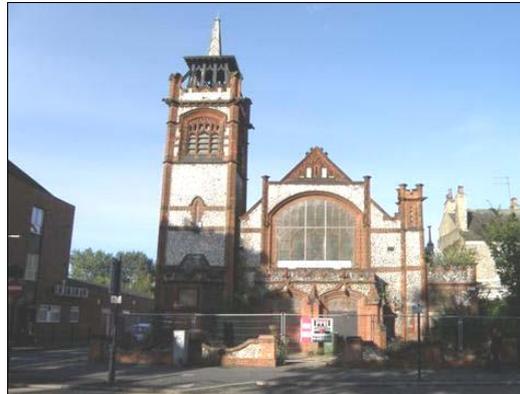
Trafalgar Street Church

Constructed in 1904, the former Baptist church is brick panelled with flint nodules, moulded brick dressings and a slate roof topped with a spired octagonal turret. Repairs and reinstatement works are proposed to the external architectural detail including flint and stone work in addition to the cast iron drainage.

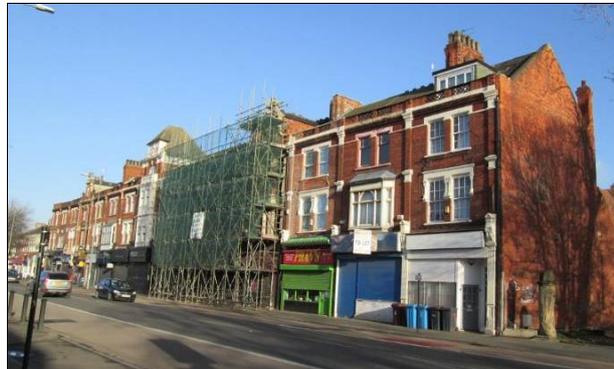
Brunswick Arcade (50-64 Beverley Road)

These historically significant buildings represent the transition of the area's residential to commercial function in the late nineteenth-century. The proposed work will include the repair and reinstatement of shop fronts and improved signage in addition to the demolition and reinstatement of the façade of 52-54a in order to create greater symmetry with the surrounding shop fronts.

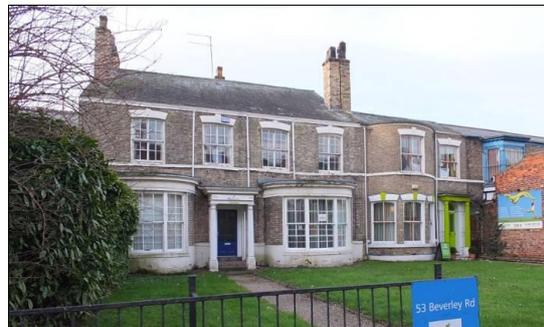
53-55 Beverley Road

Built in 1820, these Grade II listed houses are some of the earliest on Beverley Road and formed the first phase of suburban expansion. The proposed work will include repairs to the timber sliding sash windows, stonework and the roof including chimney stacks.

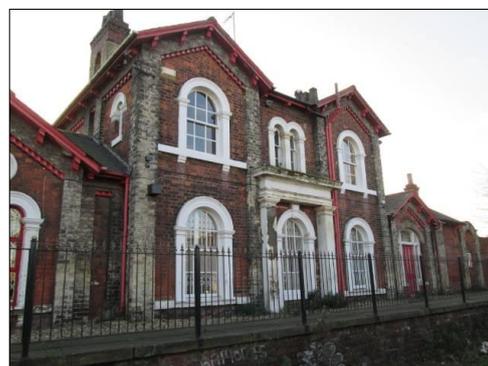
Former Stepney Station (183 Beverley Road)

The former station opened in 1853 to serve the Victoria Dock line. The proposed repairs will be carried out to the external timber, decorative stone work, the roof in addition to ground works in order to reverse damp penetration at ground level.

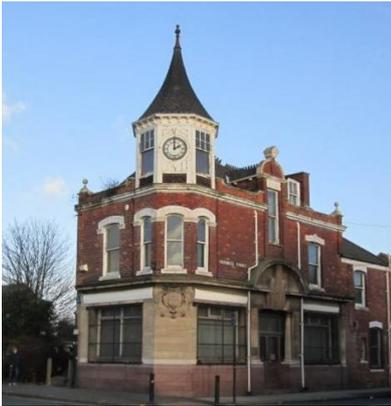
Pendrill House (190 Beverley Road)

Built in 1901, this distinctive building sports a turret and was formerly a branch of Hull Savings Bank. Proposed work will include improved shoring to the gable end and repairs to the clock tower, fenestration and architectural detail.

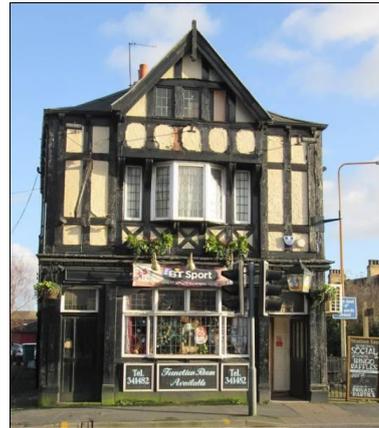
The Station Pub (202 Beverley Road)

The building was constructed in 1870 most likely as a result of the opening of Stepney Station. Proposed repairs on this 3-storey public house will be carried out to the external timber work facing south and west.

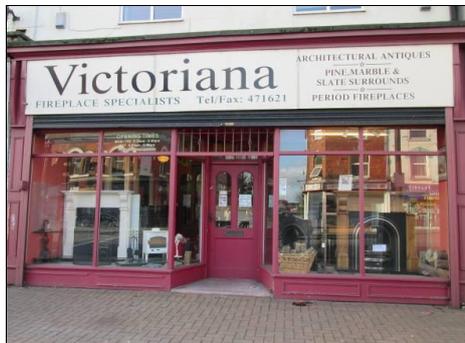
217 Beverley Road

Proposed repairs will be carried out to the frontage of this antique fireplace shop including the reinstatement of missing original features with improvements to the fascia board and signage.

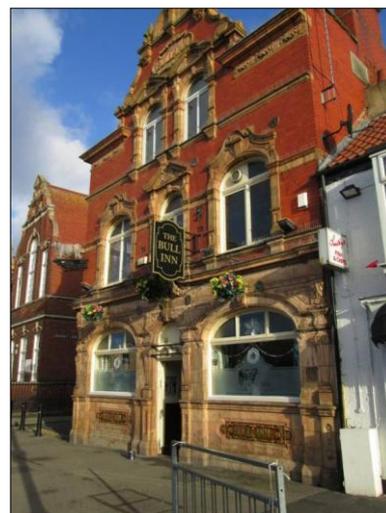
The Bull Inn (236 Beverley Road)

Constructed in 1902-03, this Grade II listed large corner public house has a prominent central gable and decorative stone dressings. Proposed work will comprise of the repair and reinstatement of etched glass and sash windows in addition to restoring the carved timber bulls heads.
